# SNEAD ISLAND MARINE SURVEYORS

## CONDITION AND VALUE SURVEY

**VESSEL'S NAME:** "SEA WOLF"

**TYPE/MODEL:** Morgan 41' 416 OI ketch

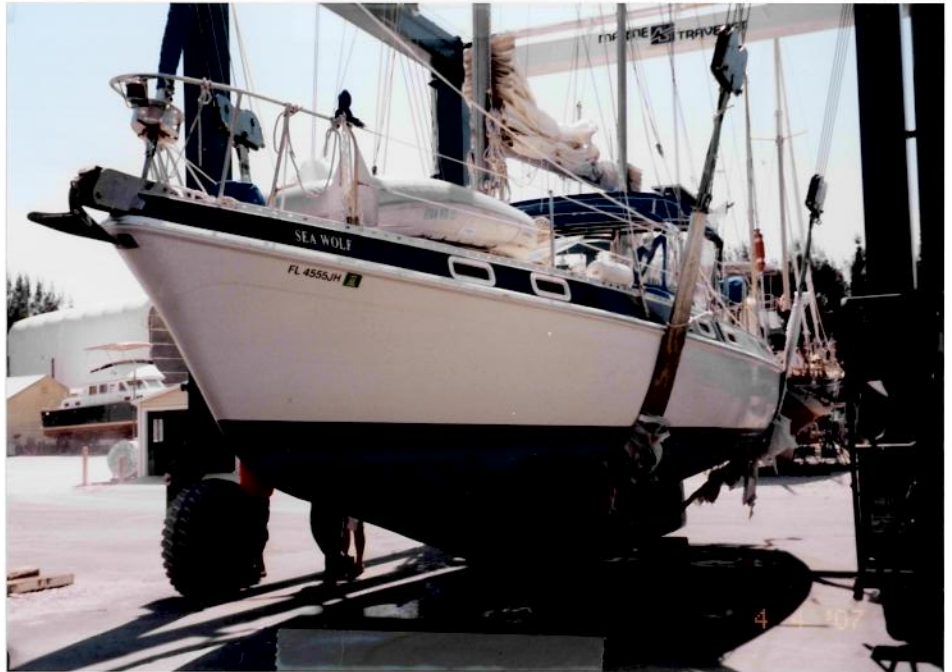
**Photo 1**

**Comments:** Subject vessel hauled out at  
Snead Island Boat Works, Palmetto, FL.

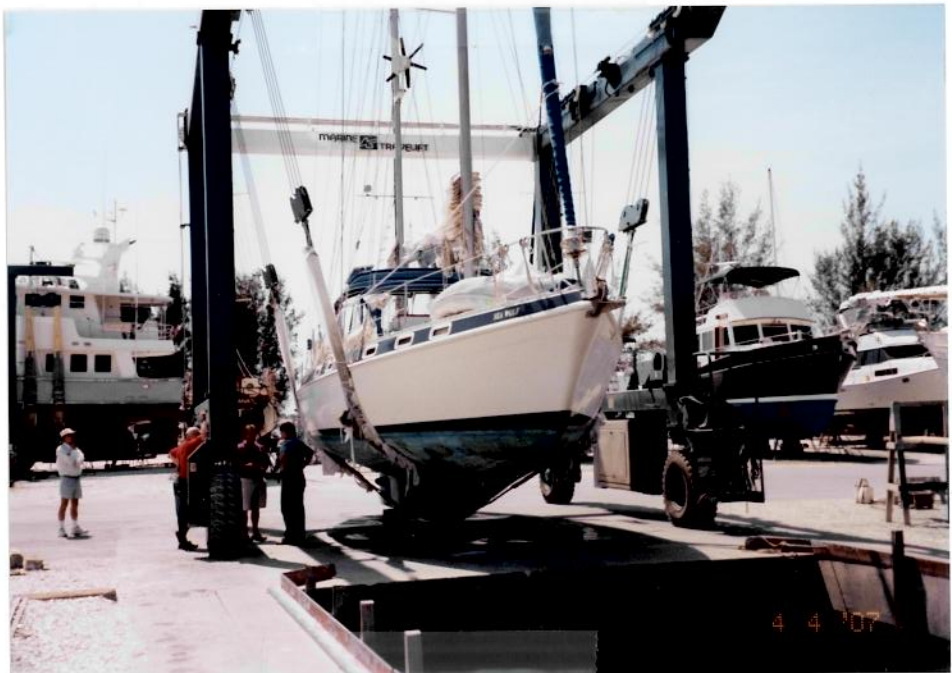
**Photo 2**

**Comments:** As above.

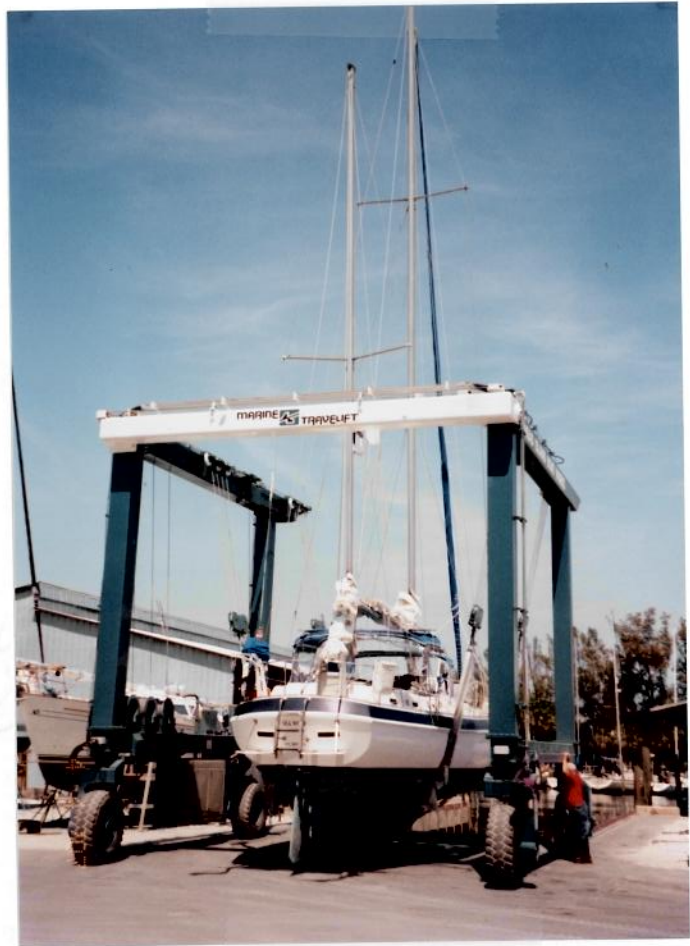
**Photo 3**

**Comments:** Subject vessel hauled out at  
Snead Island Boat Works, Palmetto, FL.

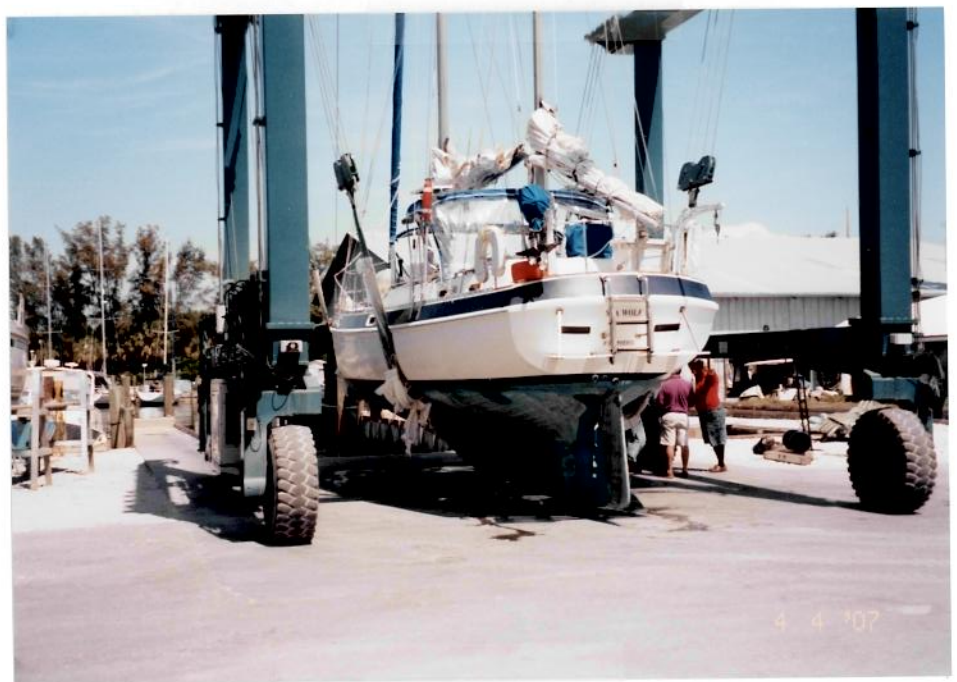
**Photo 4**

**Comments:** As above.
