Very forward block
Failure 1/19

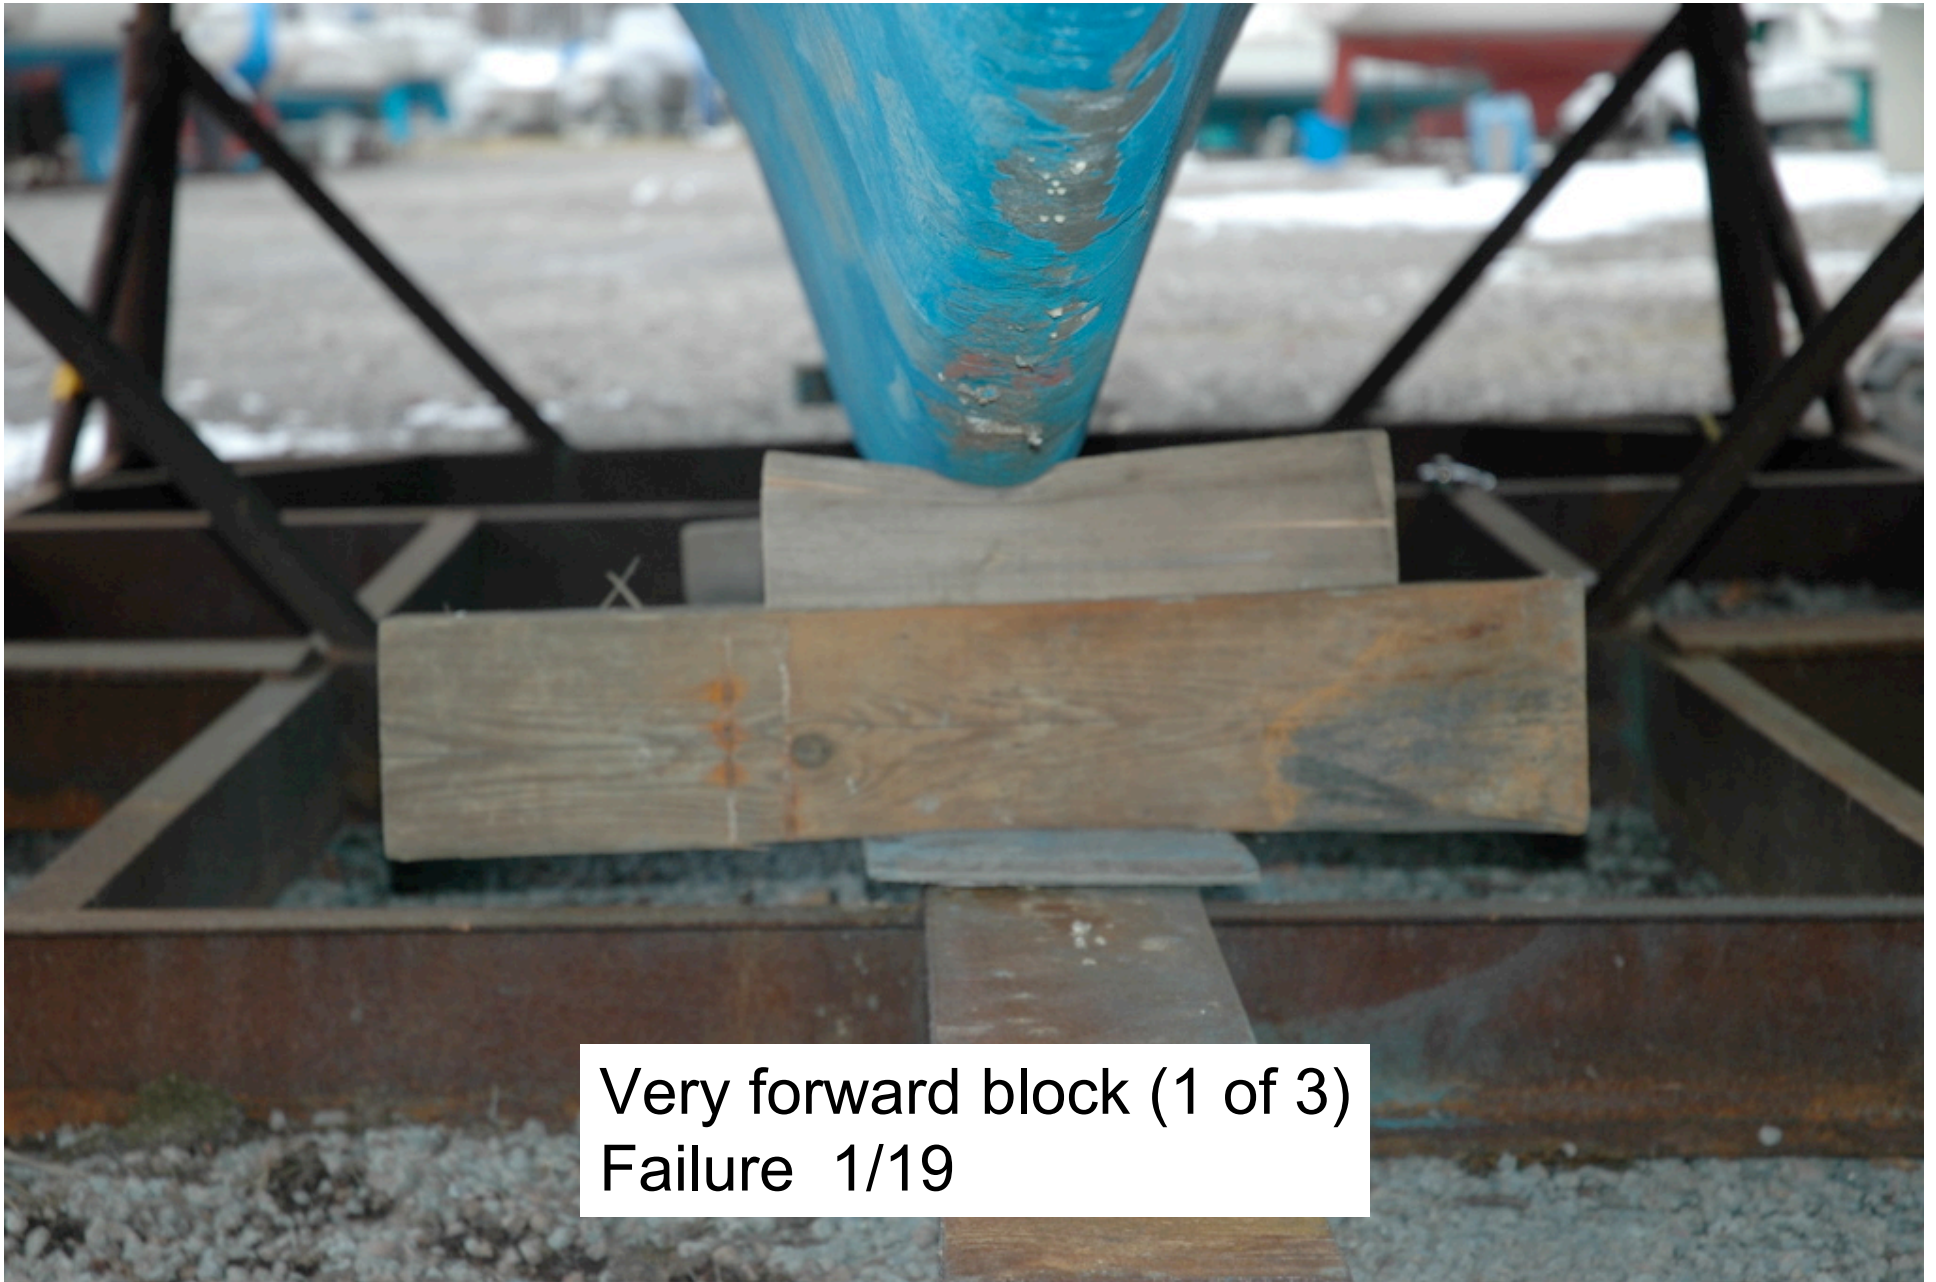
Very forward block (1 of 3)
Failure 1/19

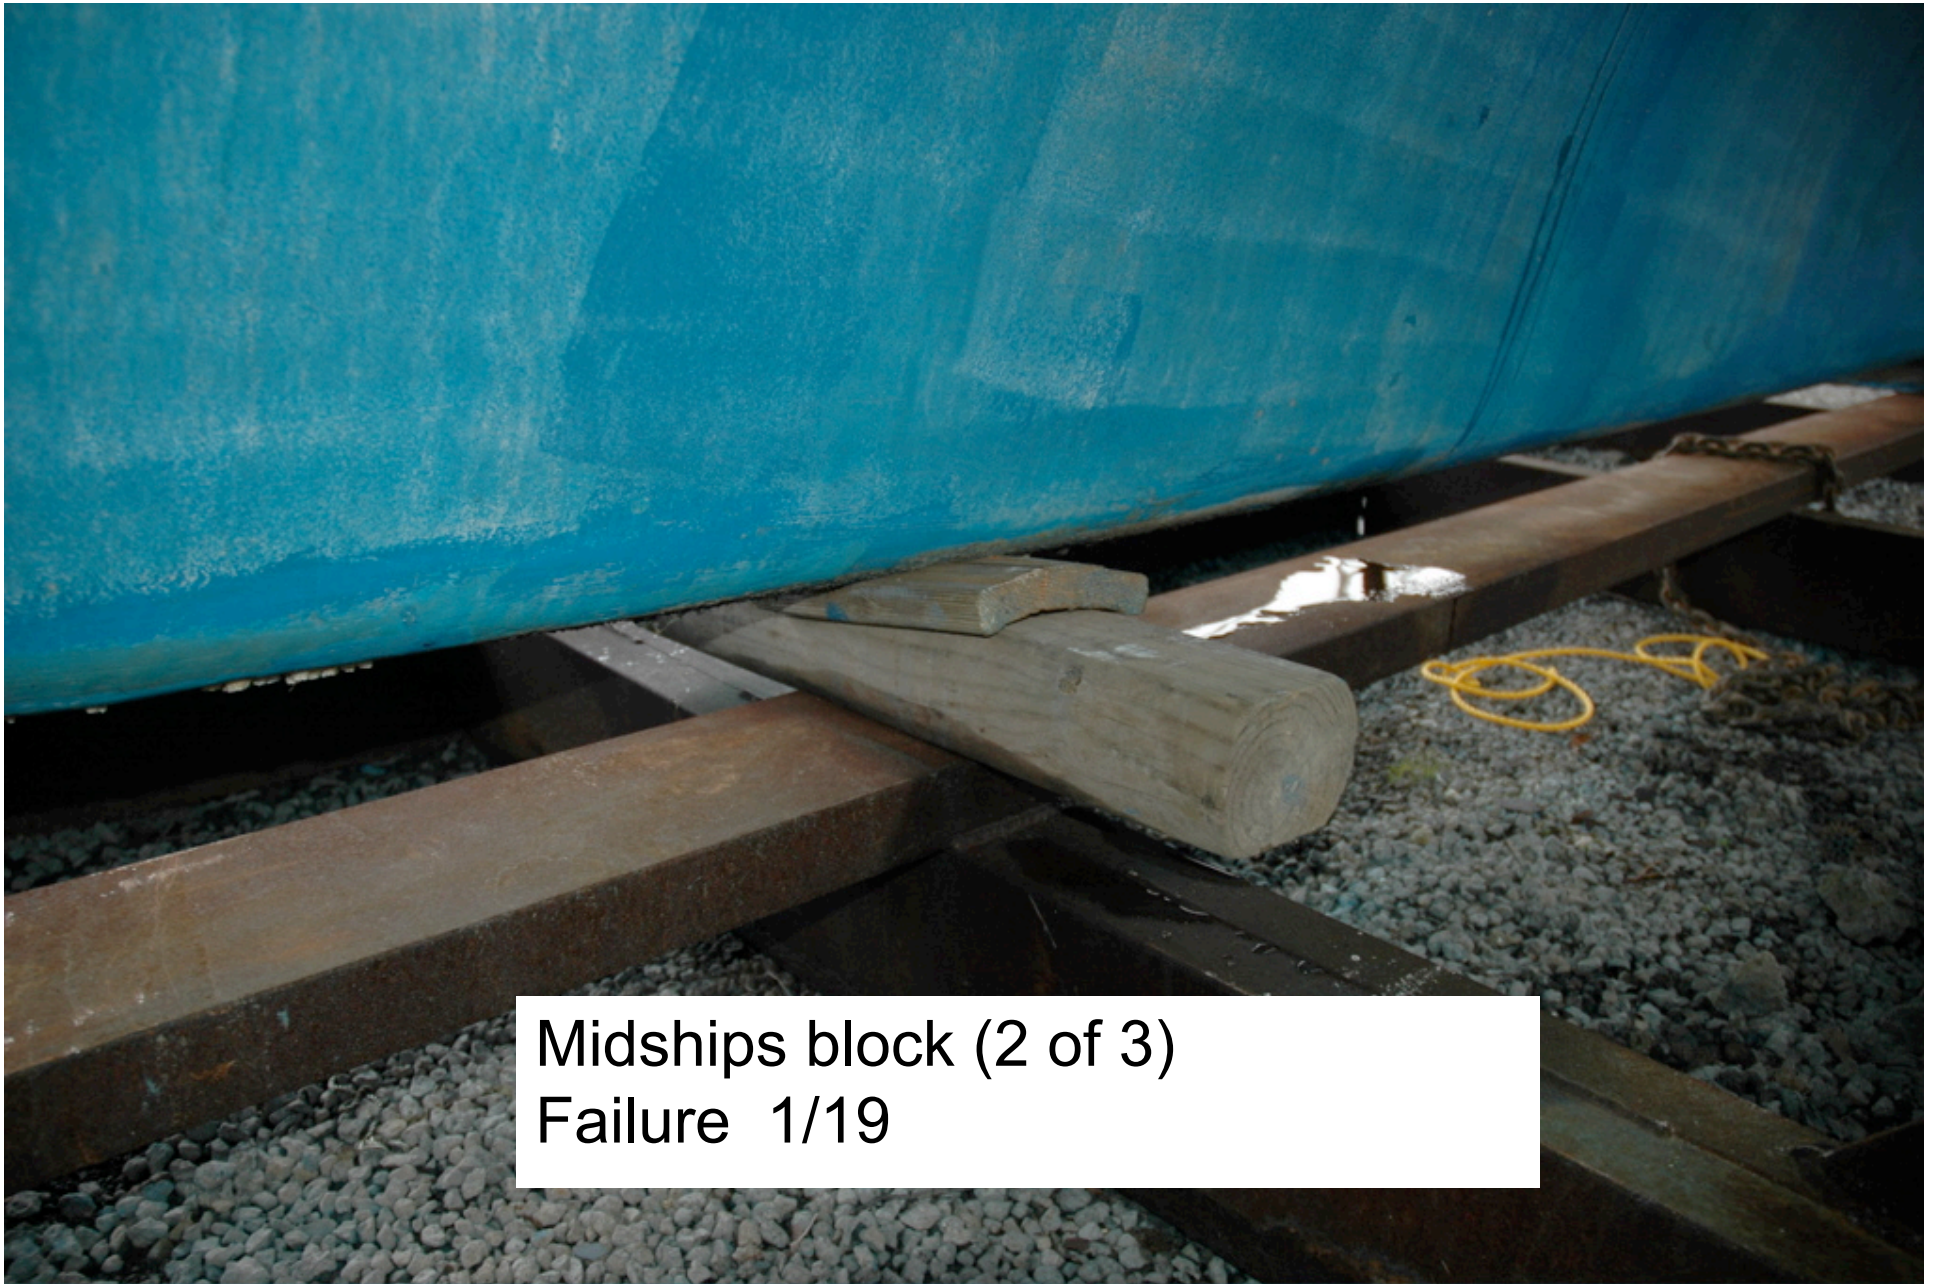
Midships block (2 of 3)
Failure 1/19

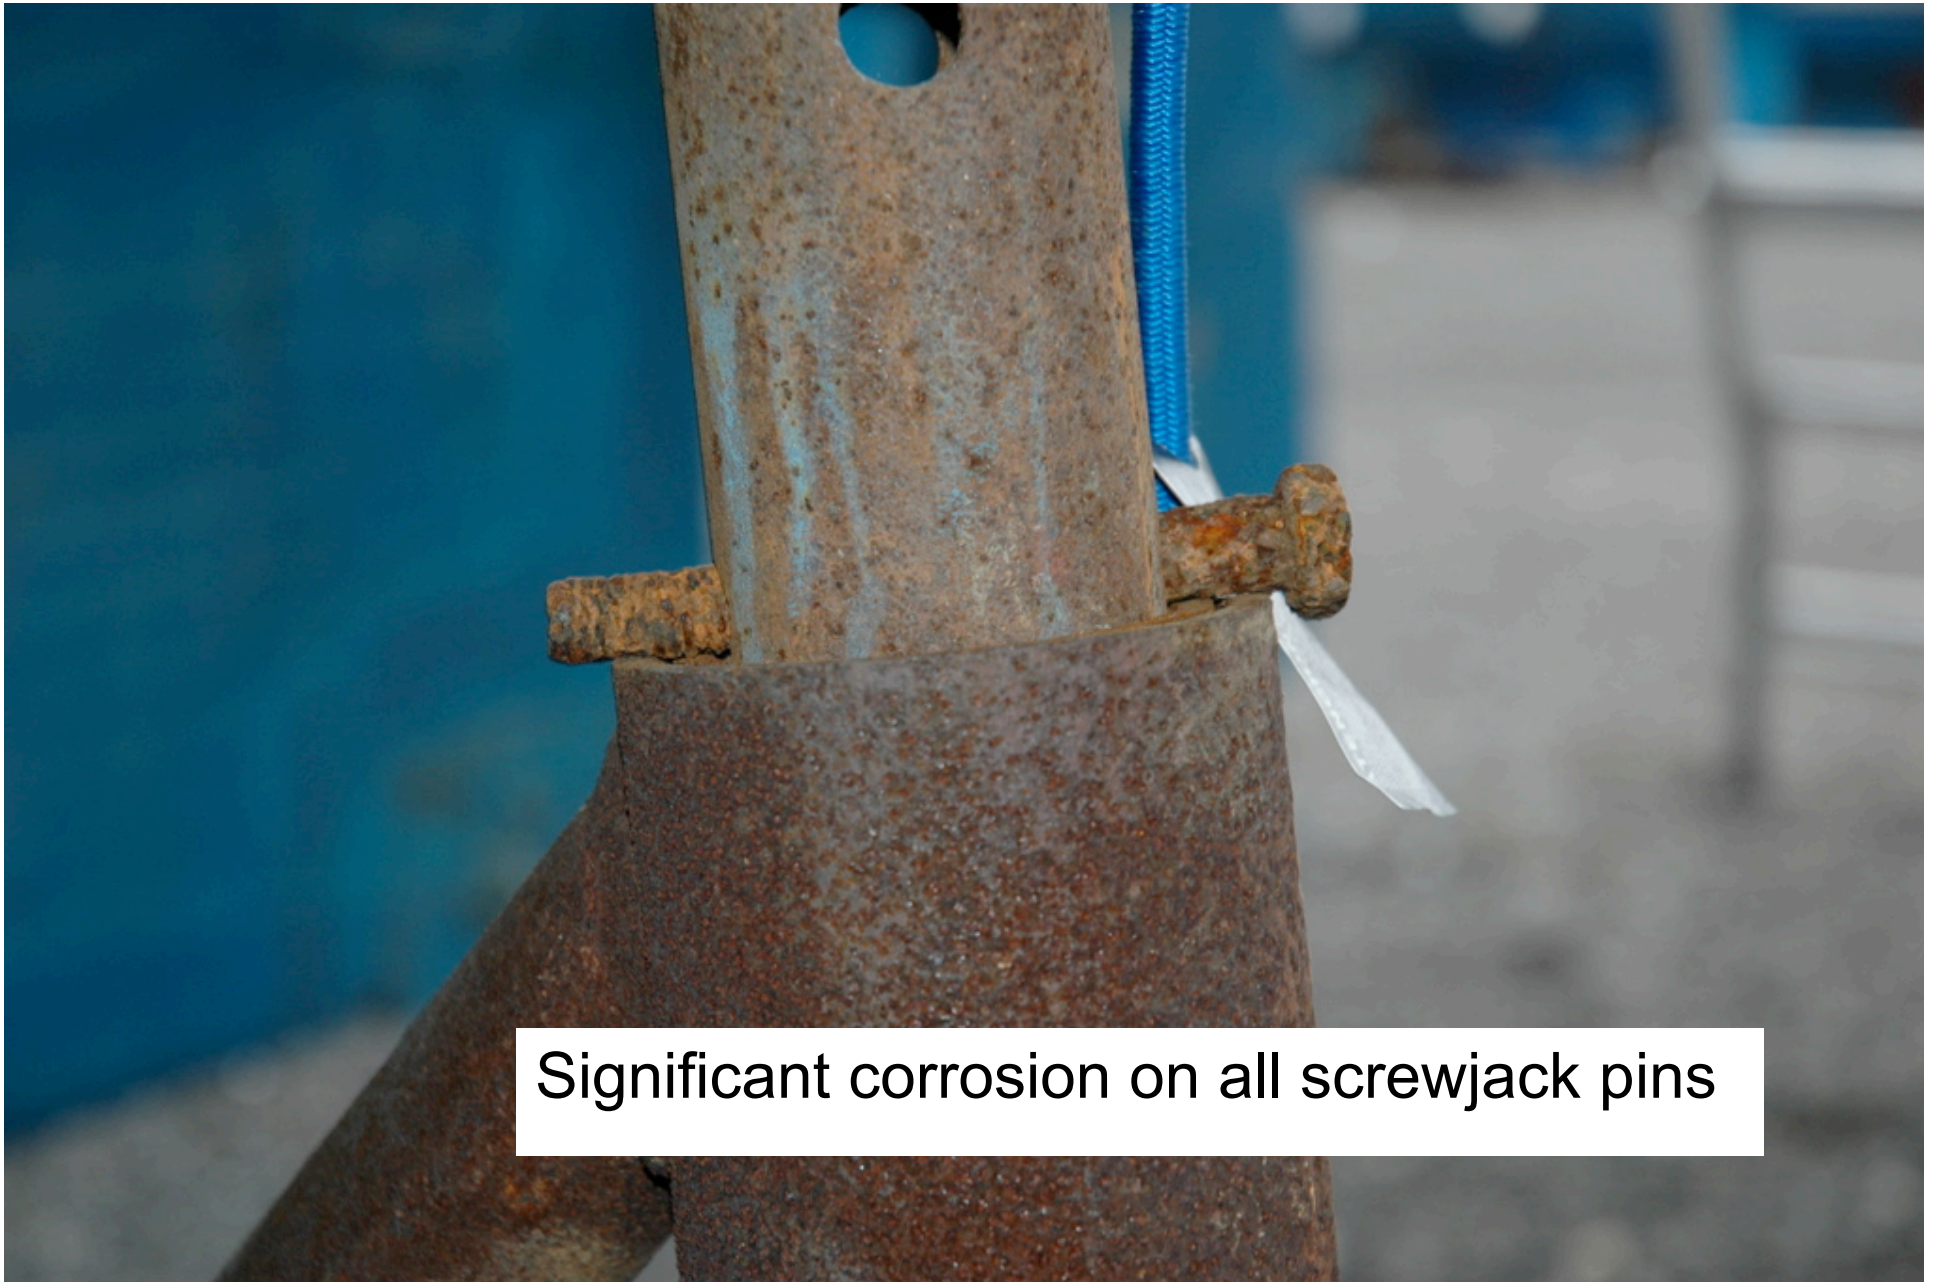
Significant corrosion on all screwjack pins

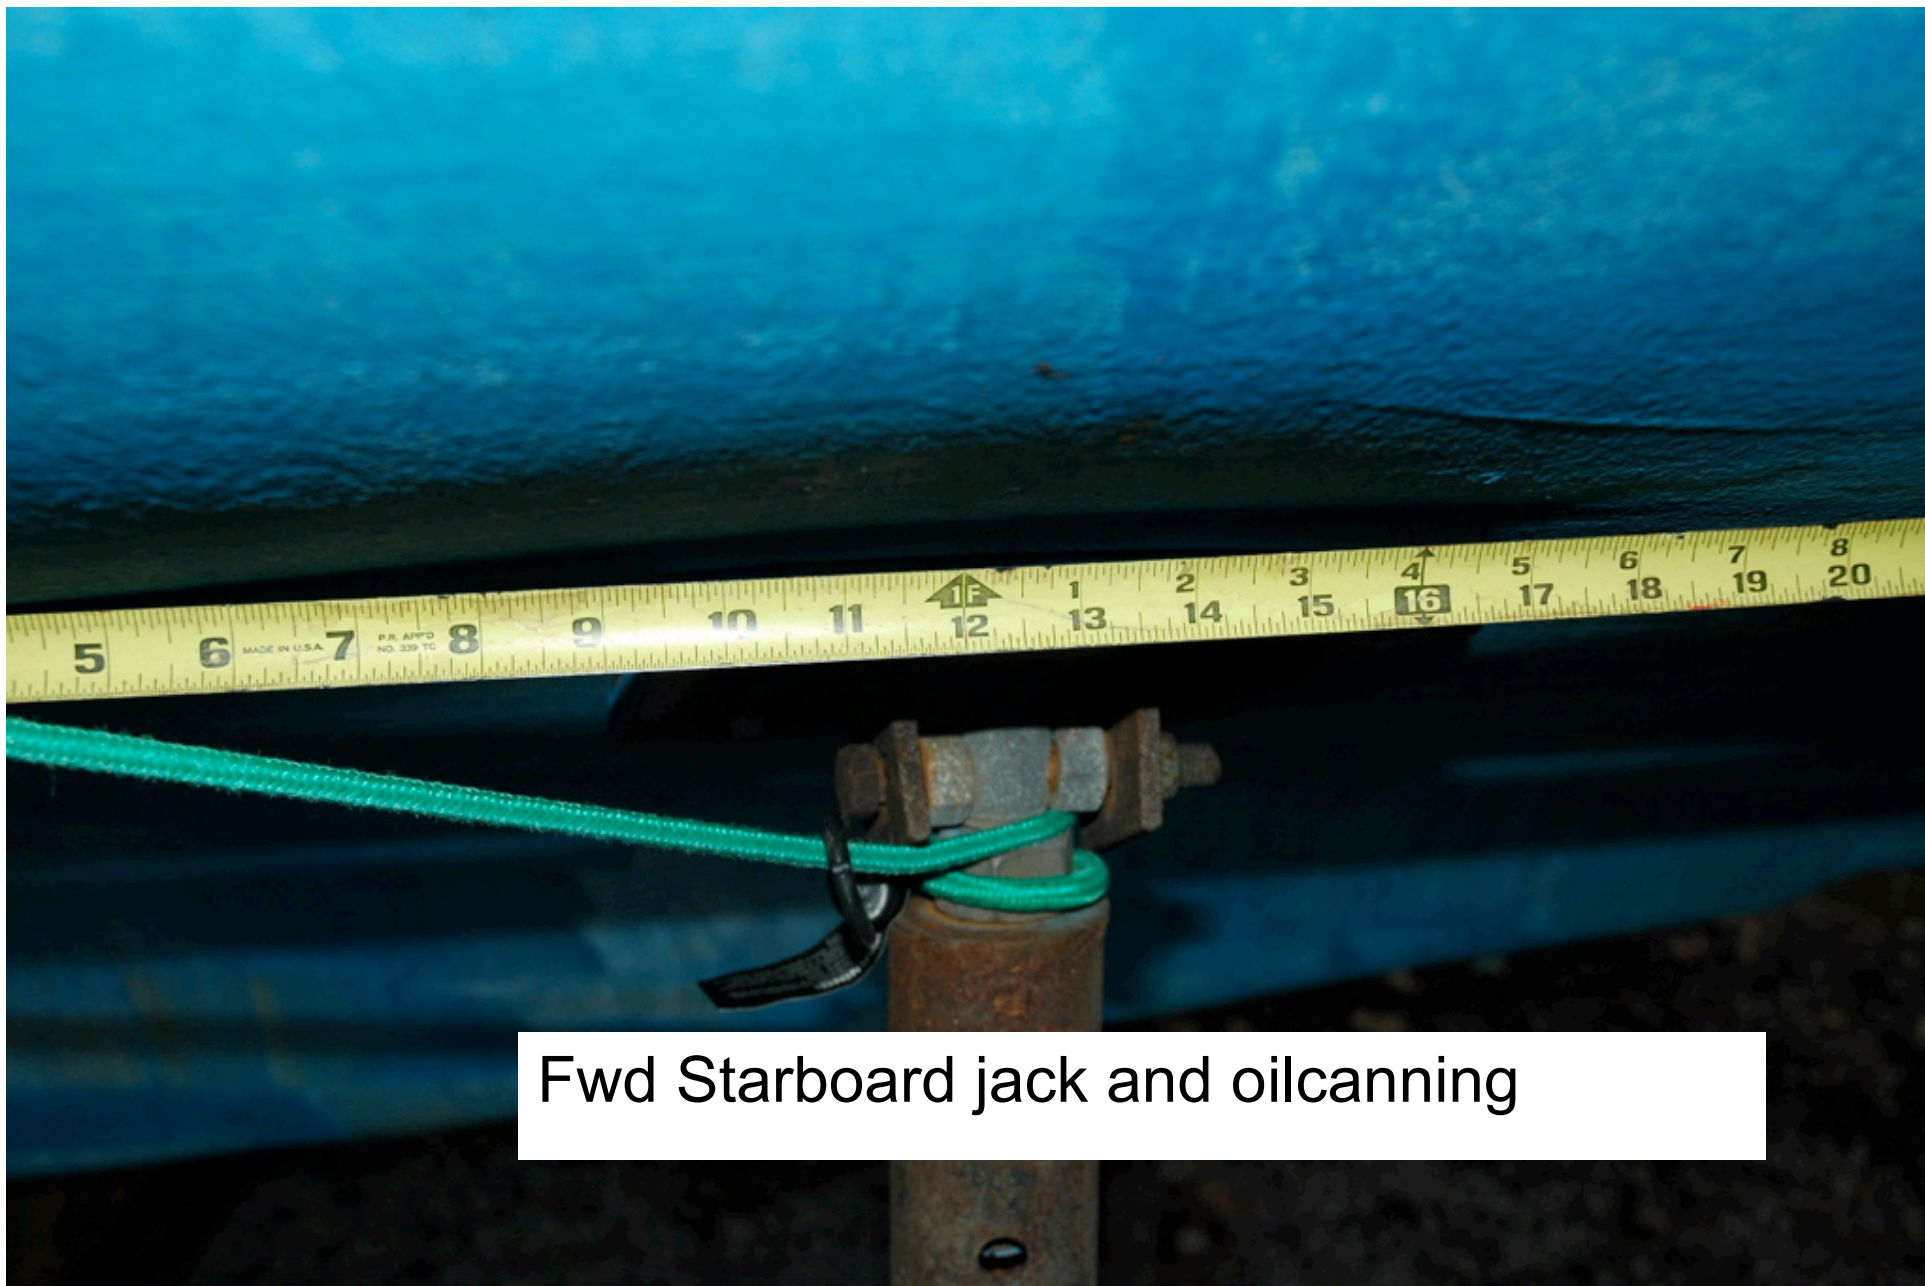
Fwd Starboard jack and oilcanning

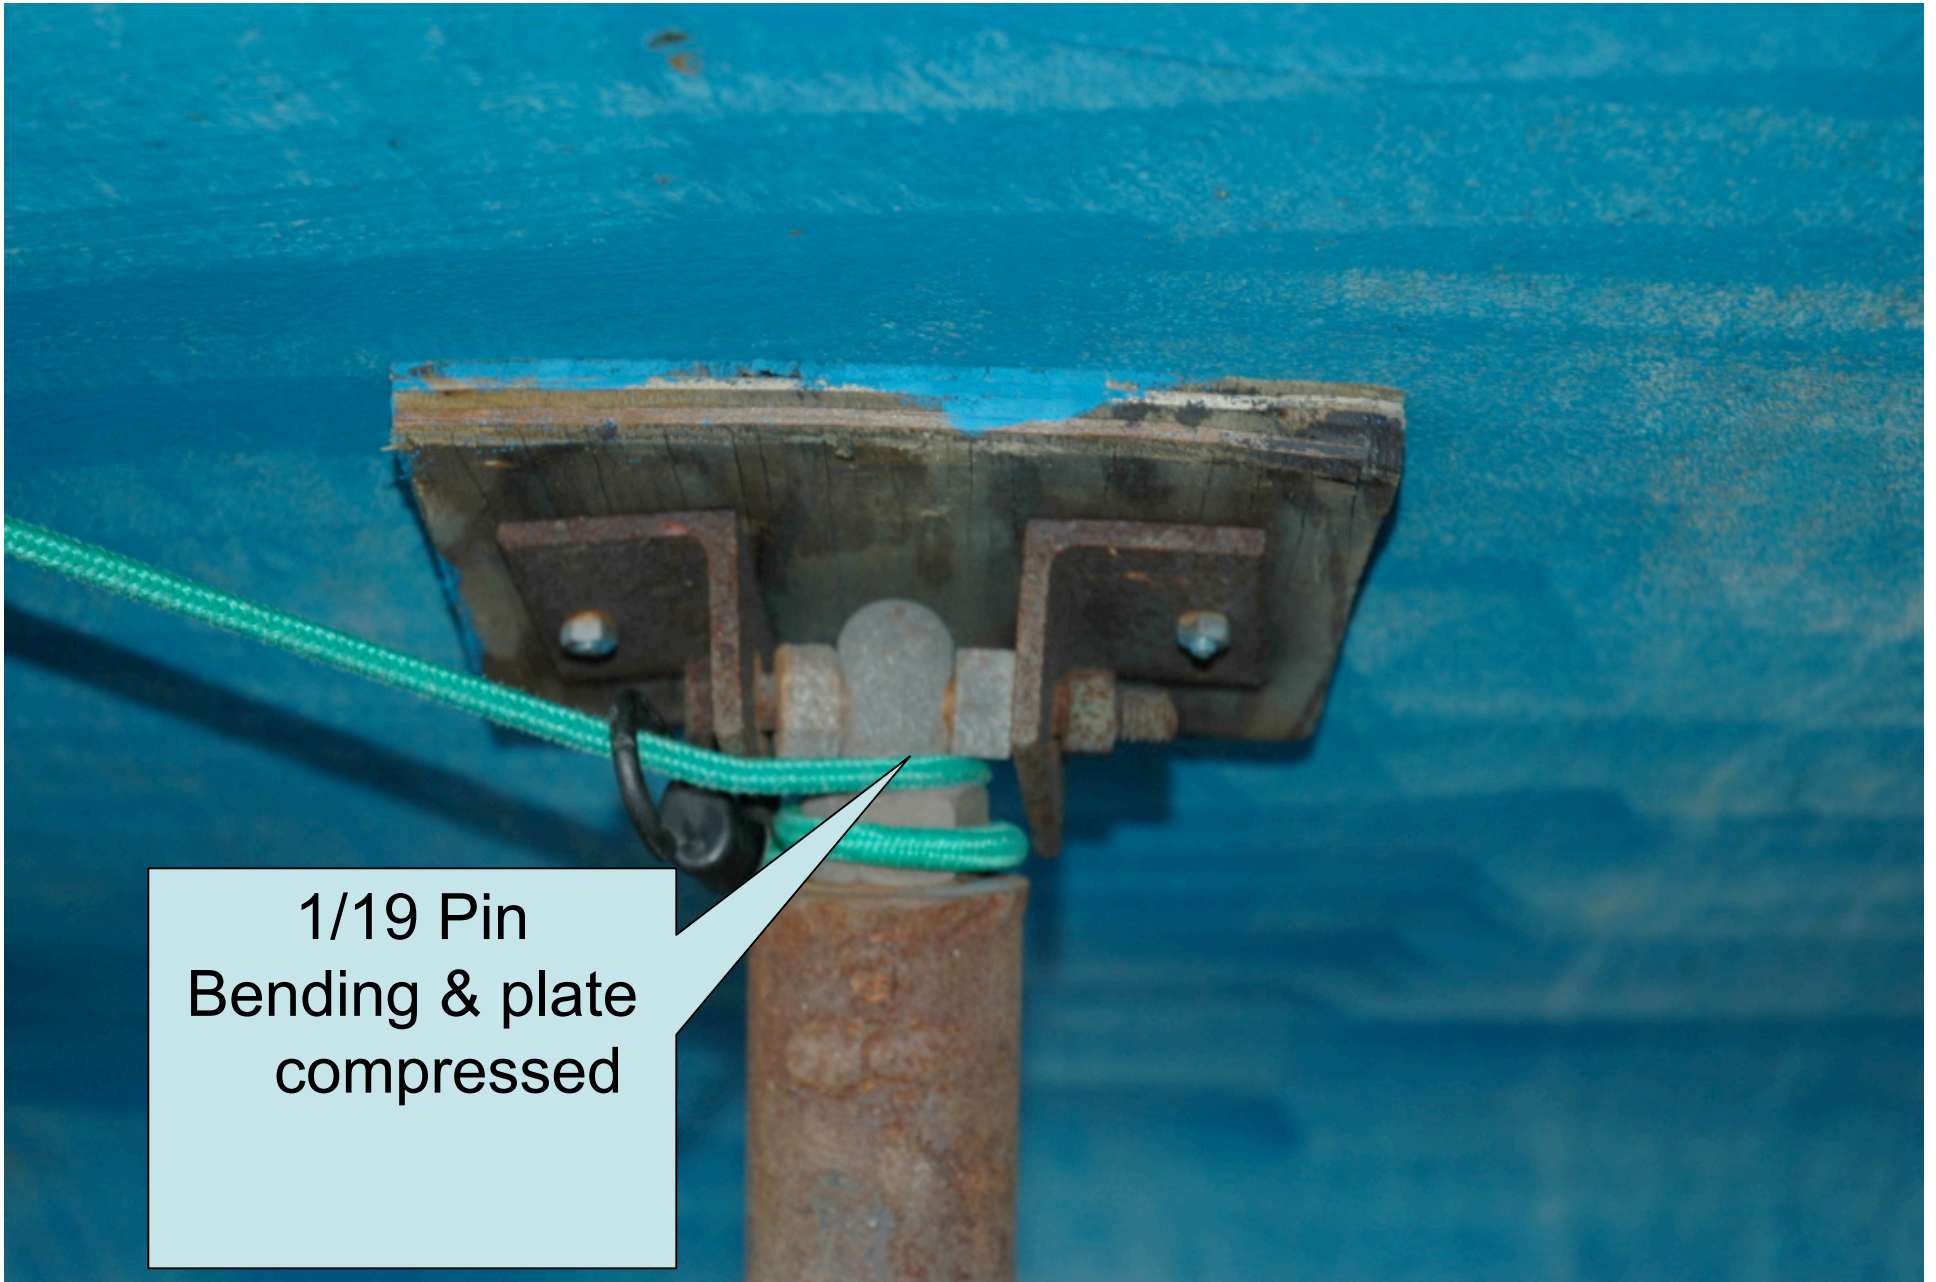
1/19 Pin
Bending & plate
compressed

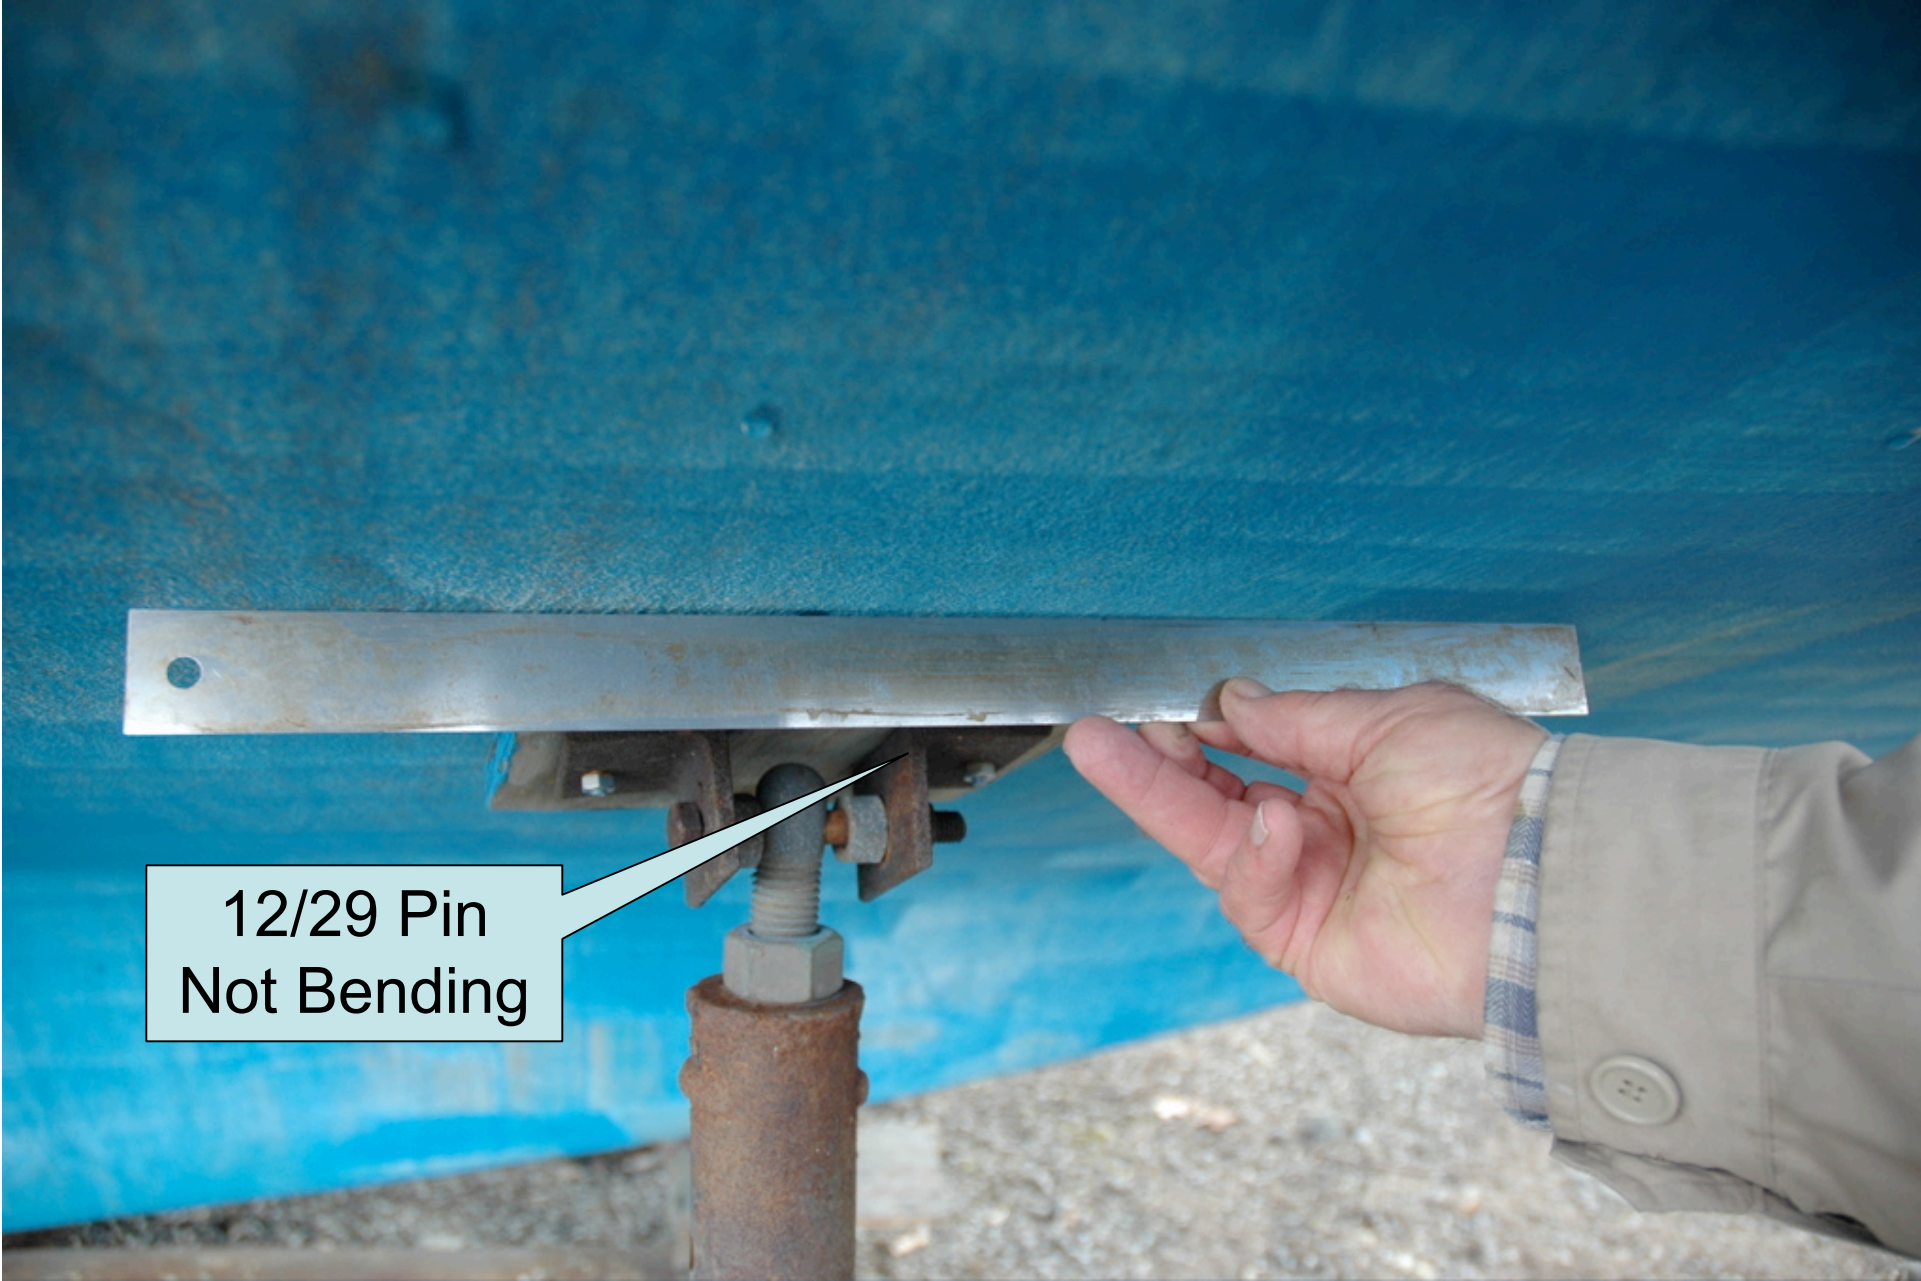
12/29 Pin
Not Bending

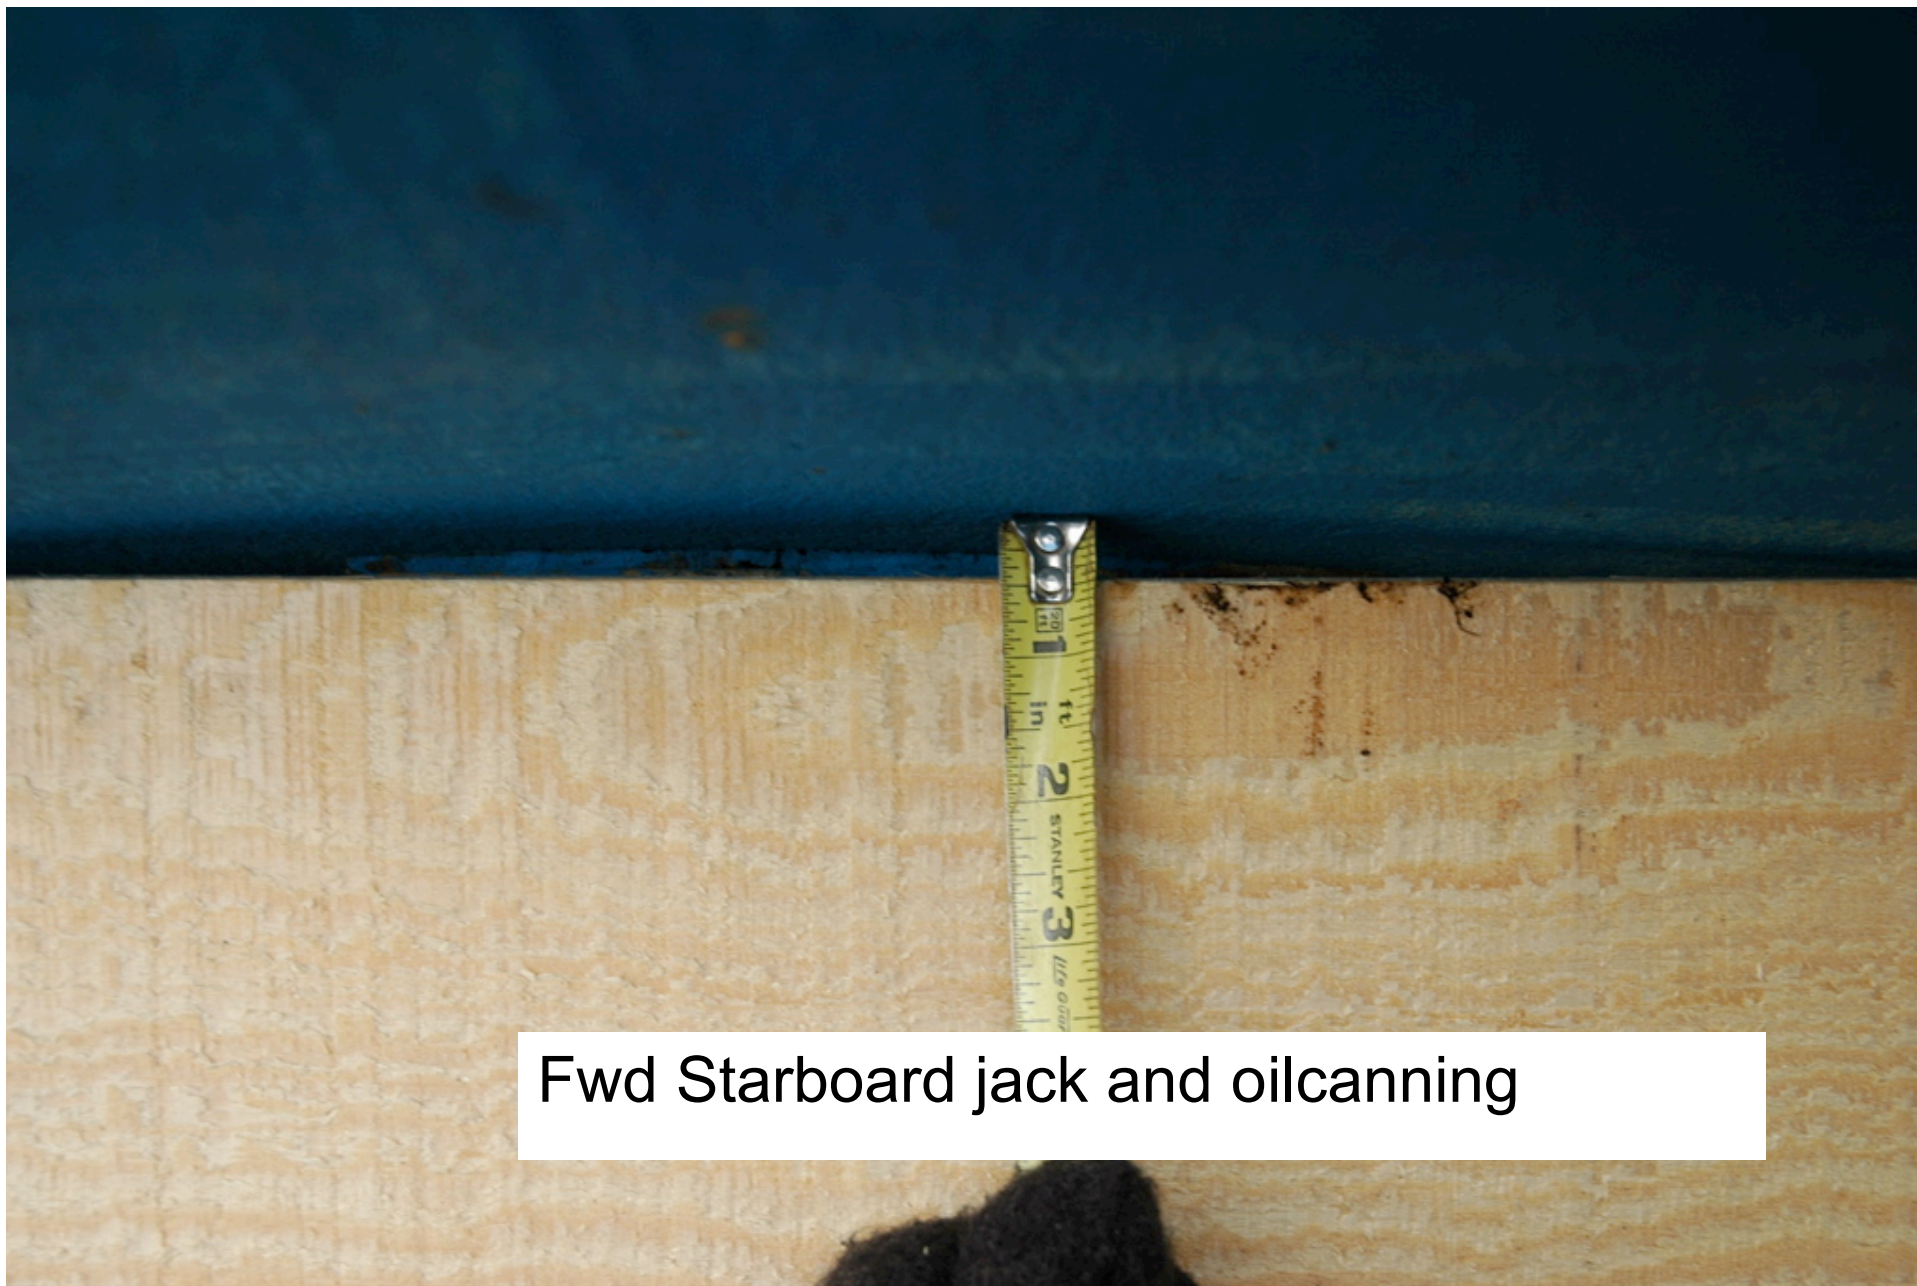
Fwd Starboard jack and oilcanning

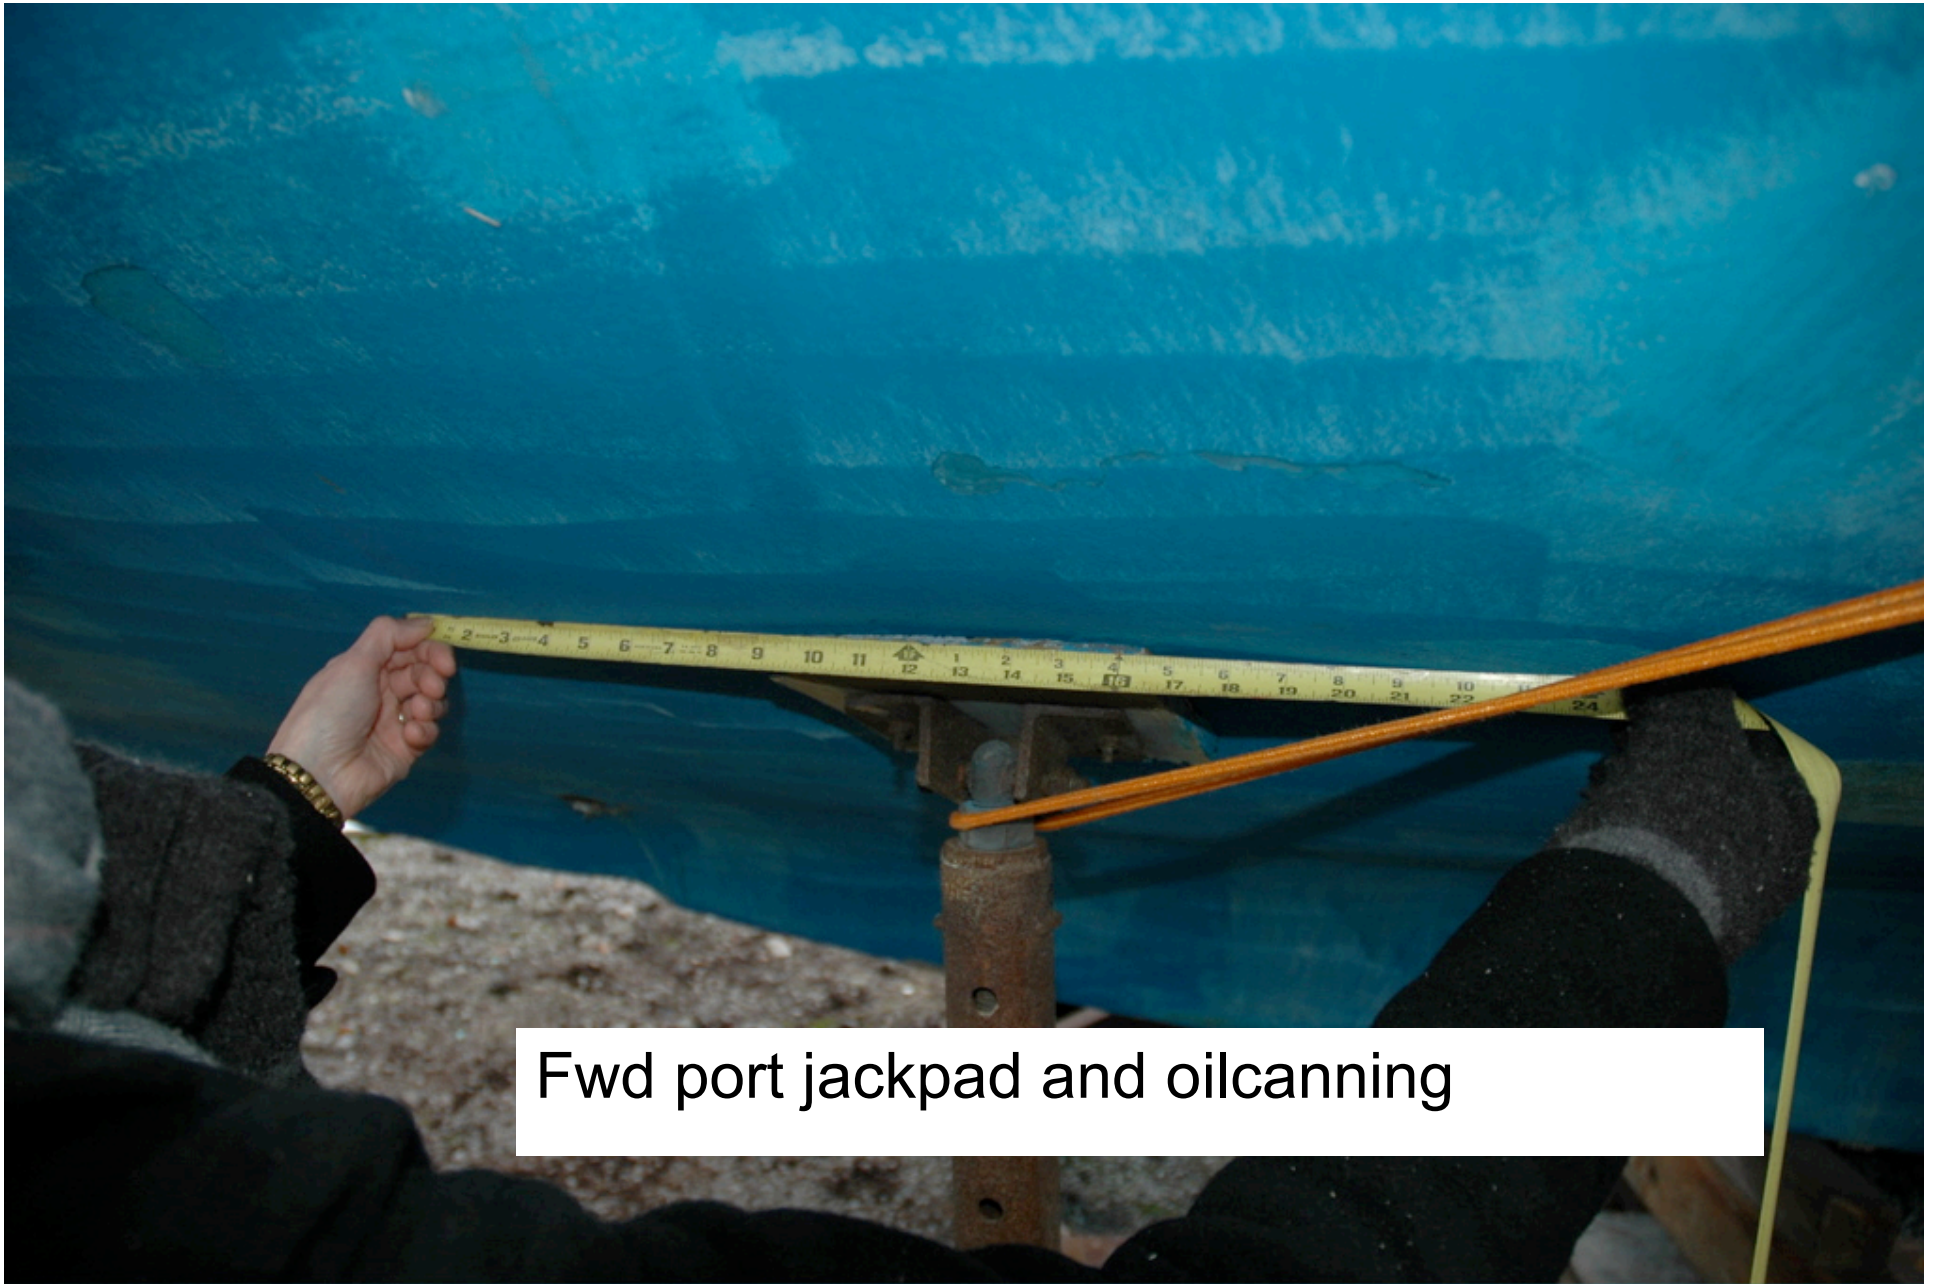
Fwd port jackpad and oilcanning

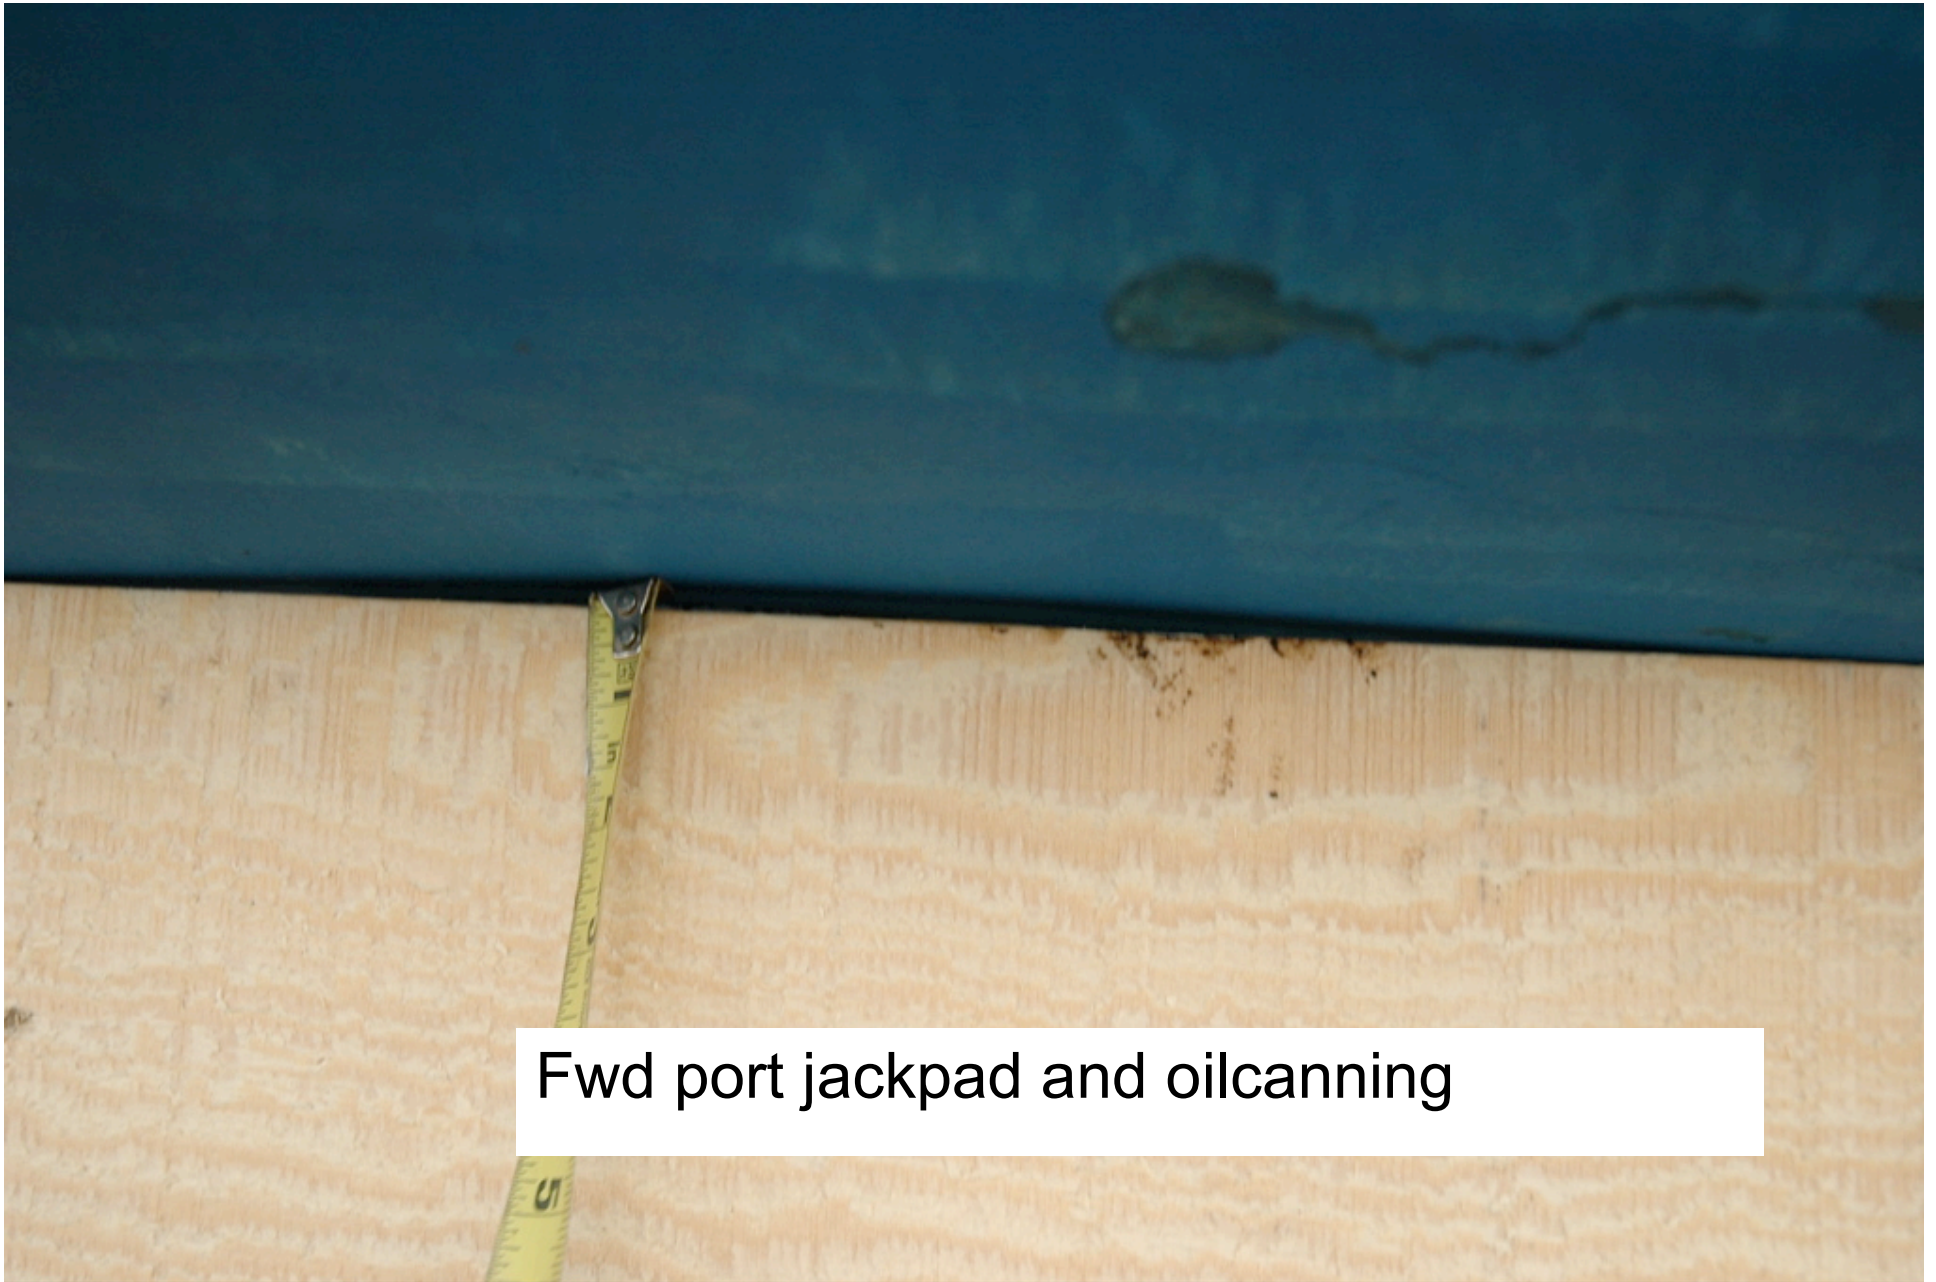
Fwd port jackpad and oilcanning
