Very forward block
Failure 1/19

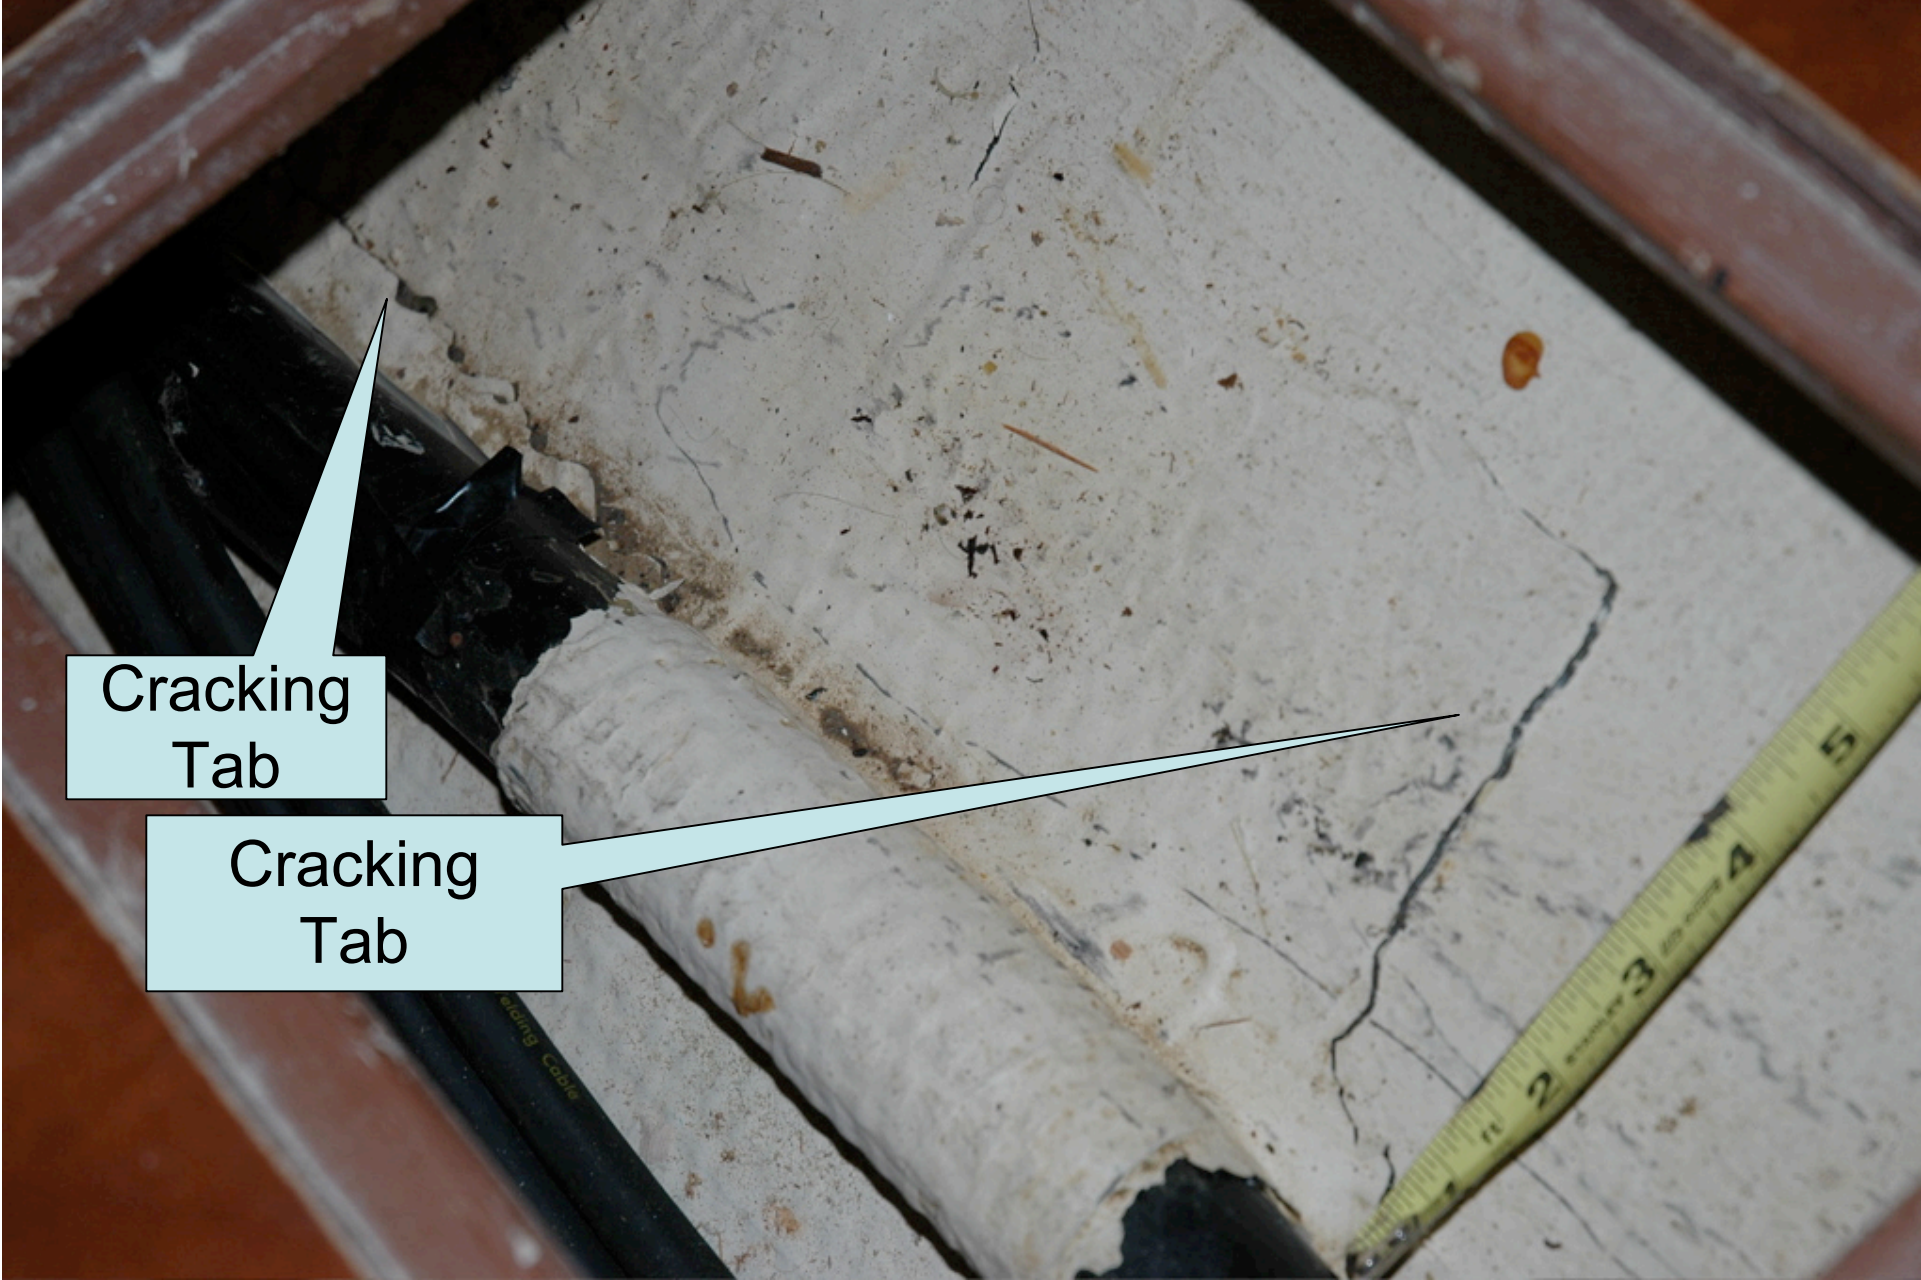
Cracking
Tab
